Immaculate Conception Rectory

INVENTORY FORM FOR STATE HISTORIC SITES SURVEY

200 Ware Avenue

Towson

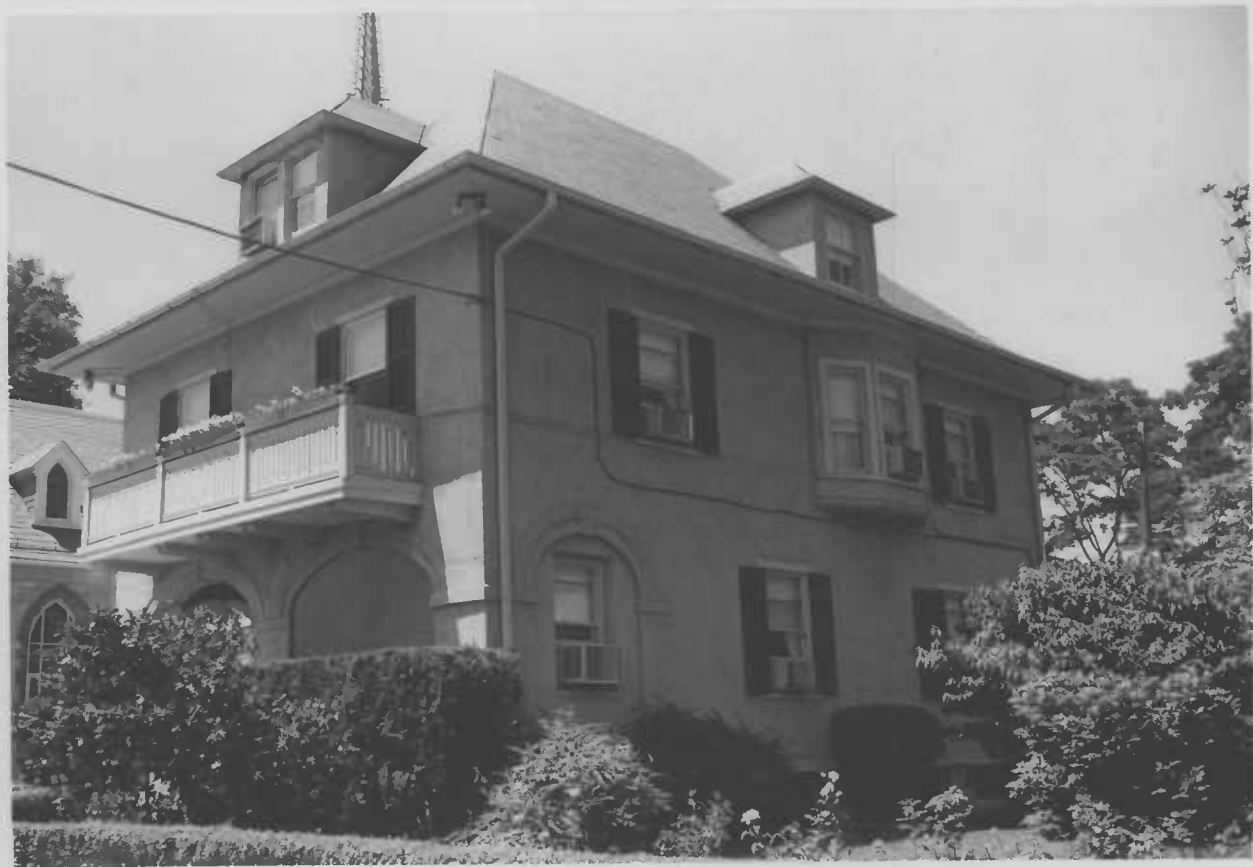
BA-1394

The Immaculate Conception Rectory, which is located on a ridge North of Ware Avenue in addition to the Church, Convent and school buildings, is a stuccoed two story slate roofed structure rich in Victorian elements which are exhibited in its plan and ornamentation. The main or south facade is two bays wide and features a recessed porch two bays wide (partially enclosed by one bay) which has round arches with keys. A small, almost square window with shutters and a doorway with transom are housed in the porch (doorway is located West of the center of the facade). The second story has a gallery supported by cantalevers, and is enclosed by a board railing which is decorated by negative space carvings with a fleur de leis pattern. Two 1/1 sash windows with shutters are present on this story. The structure is also characterized by deep overhanging eaves. Also visible on the south facade is a hipped roof dormer vented by two 1/1 sash windows.

The east facade is three bays deep; the porch constitutes the third bay resulting in irregular fenestration. The second story features a large bay window which is composed of three lights, and includes one large 1/1 sash window flanked by two smaller 1/1 sash windows. Also present are two 1/1 windows with shutters. The first story features the round arch of the porch, one 1/1 window with shutters which measure 6' x 3'. A hipped roof dormer vented by two 2/2 windows is present. Also visible on the east facade is a high (28") stone foundation which exhibits some elements of coursing and beaded grouting. A cellar entrance located slightly to the North of the center which is flanked by a 1/1 casement window is also visible.

IMMACULATE CONCEPTION
RECTORY
S.E. CORNER

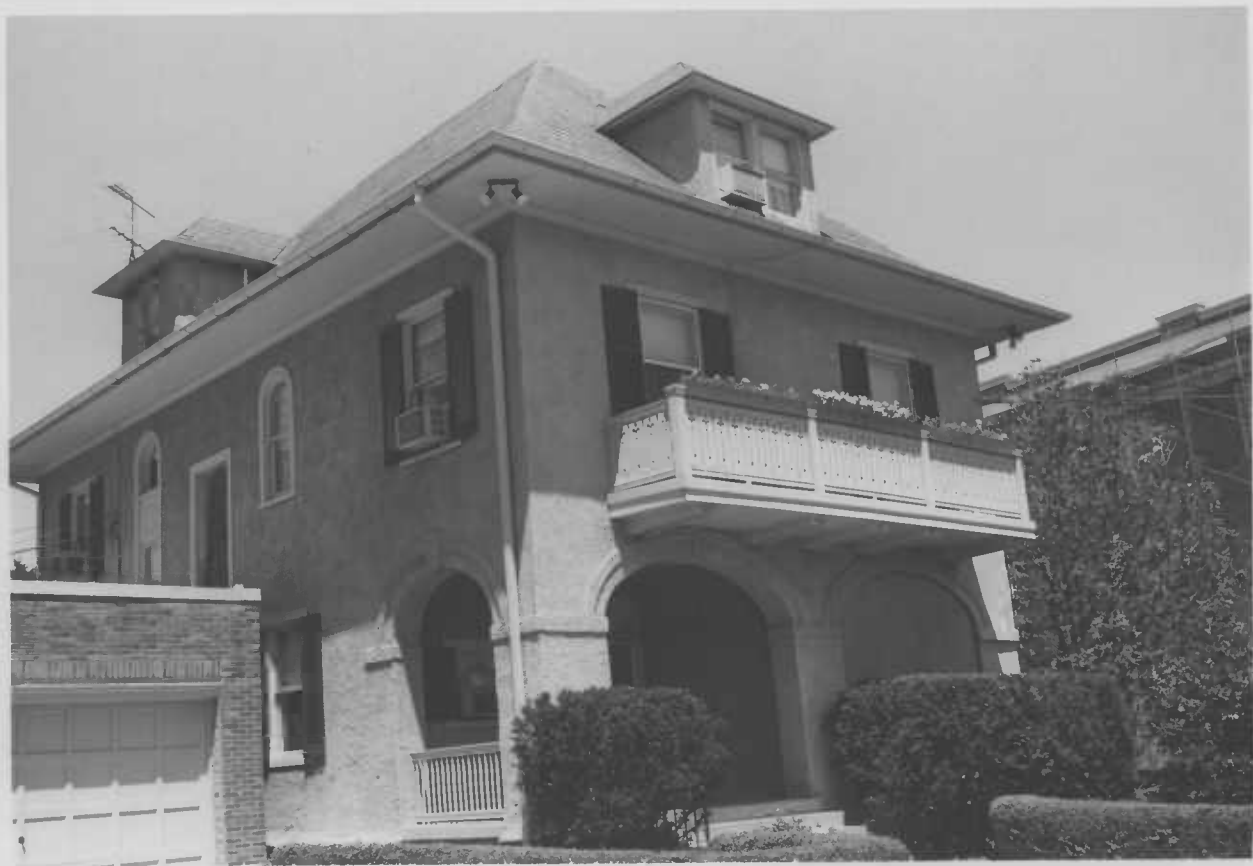
BA-1394

The west facade is the size of three bays but is vented by numerous, variously shaped and placed windows. On the first story there is a centrally located entrance with gable end hood and slate roof. Above the hood but off-center is a lead and stain glass window, which is flanked by two round arch windows. On either side of the round arch windows are one 1/1 sash shuttered windows. The round arch window to the north is a full story in height and incorporates a sash window and a panel in its framework. On the first story there are three 1/1 sash windows with shutters and four small windows vent the basement. Much of the west facade was difficult to describe because a single story brick garage is located three feet away from this side.

IMMACULATE CONCEPTION

RECTORY

S.W. CORNER
